Louis Berger

STRUCTURAL INTEGRITY EVALUATION OF THE “CONSTITUCIÓN DE 1812” BRIDGE, OVER THE CÁDIZ BAY (CÁDIZ, SPAIN)

Santander, may 2018

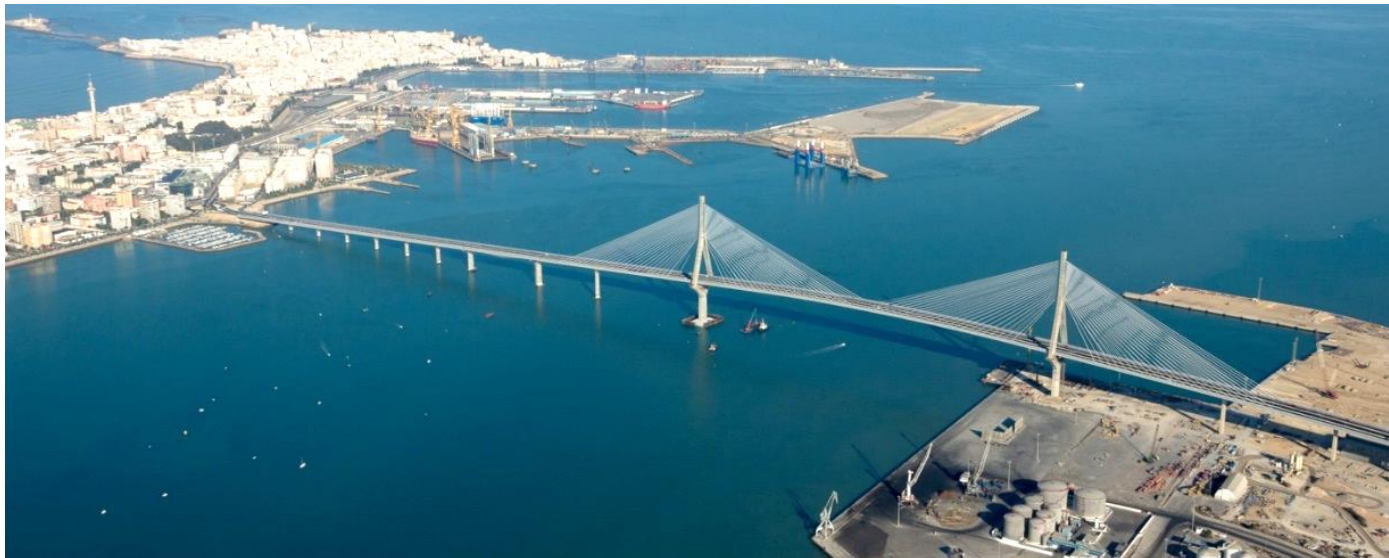
- **Constitución de 1812 bridge**

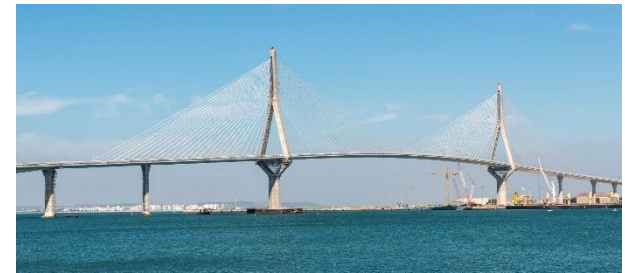
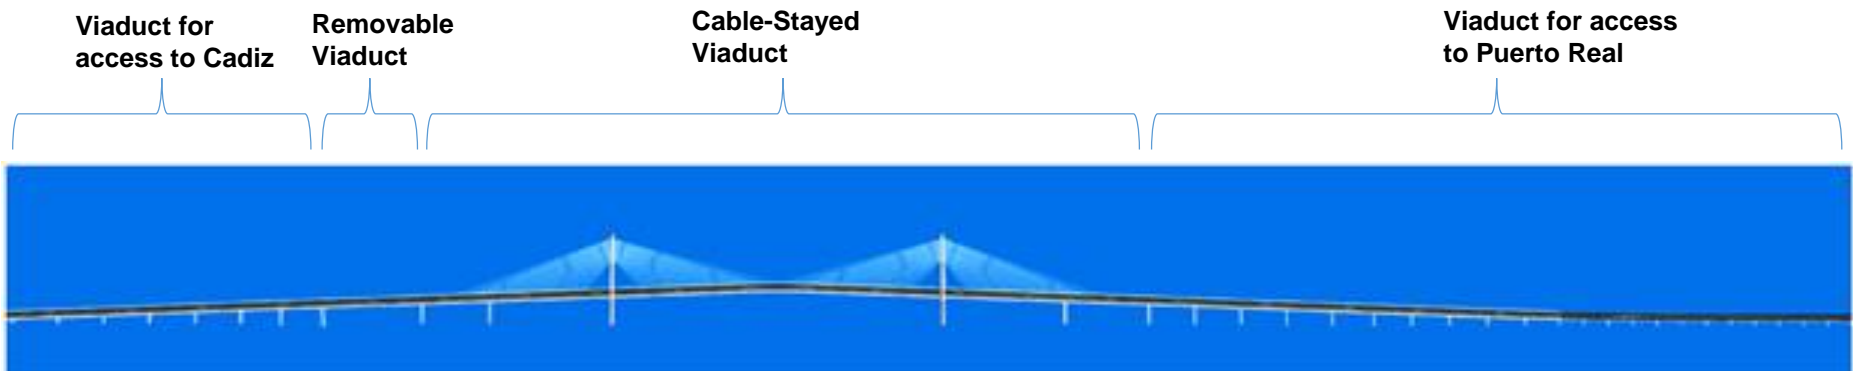
CONSTITUCIÓN DE 1812 BRIDGE. CÁDIZ

Total length.....3.157 m
Deck width.....34.3 m

Viaduct for access to Cádiz.....645 m
Removable viaduct.....150 m
Cable-Stayed viaduct.....1.180 m
Viaduct for Access to Puerto Real1.182 m

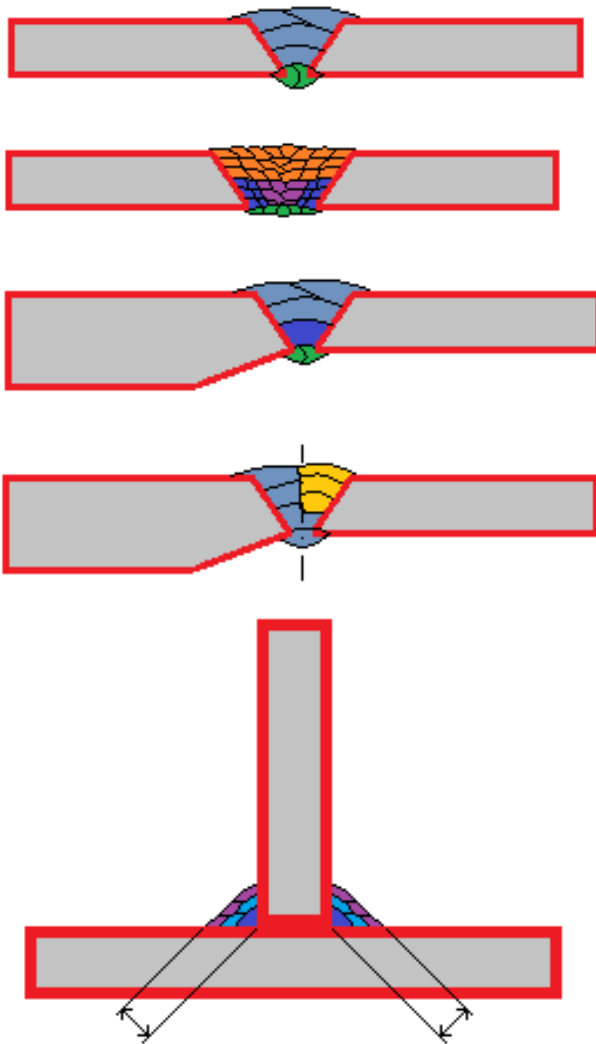
136-FCAW EN ISO 4063
121-SAW EN ISO 4063

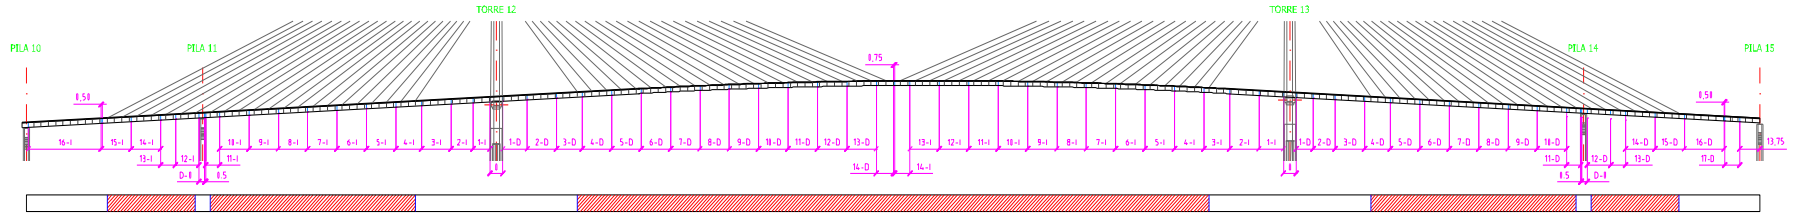
Transversal direction

- Butt joints plates 1 and 4
- Butt joints plate 2 (lower area)
- T joints in plates 1 and 4

Longitudinal direction:

- Butt joints plates 1 and 4 (diaphragms of cables)
- T joints in plates 1 and 4
